DEPARTMENT OF TRANSPORTATION

Contract #: 04-0120F4Cty: SF/ALA Rte: 80 PM: 13.2/13.9File #: 69.28**WELDING INSPECTION REPORT****Resident Engineer:**Pursell, Gary**Address:** 333 Burma Road**City:** Oakland, CA 94607**Report No:** WIR-012570**Date Inspected:** 22-Feb-2010**Project Name:** SAS Superstructure**OSM Arrival Time:** 645**Prime Contractor:** American Bridge/Fluor Enterprises, a JV**OSM Departure Time:** 1845**Contractor:** Zhenhua Port Machinery Company, Ltd (ZPMC), Changxing Island **Location:** Shanghai, China**CWI Name:** You Qi Guo**CWI Present:** Yes No**Inspected CWI report:** Yes No N/A**Rod Oven in Use:** Yes No N/A**Electrode to specification:** Yes No N/A**Weld Procedures Followed:** Yes No N/A**Qualified Welders:** Yes No N/A**Verified Joint Fit-up:** Yes No N/A**Approved Drawings:** Yes No N/A**Approved WPS:** Yes No N/A**Delayed / Cancelled:** Yes No N/A**Bridge No:** 34-0006**Component:** Tower Components**Summary of Items Observed:**

WELDING INSPECTION REPORT

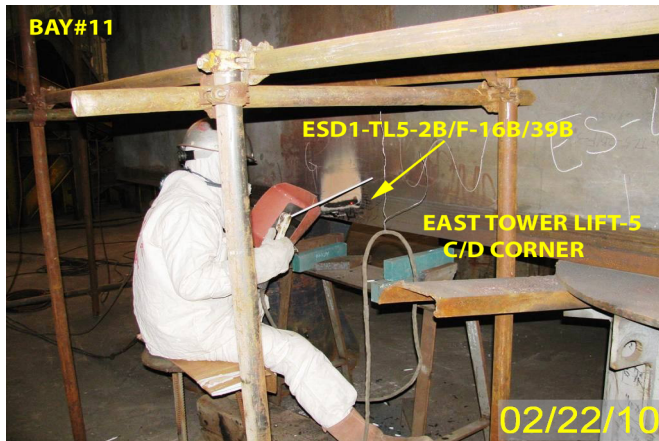
Weld joint # 16B/39B located on East Tower Lift-5 C/D corner ESD1 – TL5 – 2B/F. Welder is identified as 066361. ZPMC Quality Control (QC) Inspector is identified as Li Lin. The welding variables recorded by QC appeared to comply with the WPS – B – T – 3212 – C – U2. (See attached photo)
